Manhole Inspection Summary

Manhole # S2111_004MH

Insp Date: **5/5/08 9:13 AM**

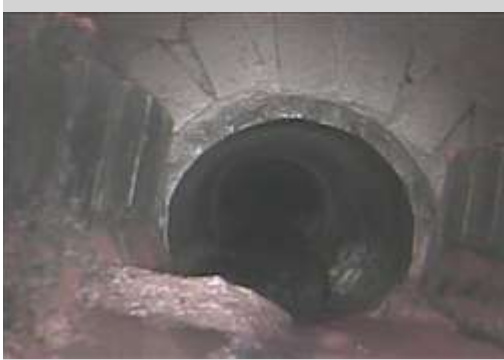
Misc

Channel Debris

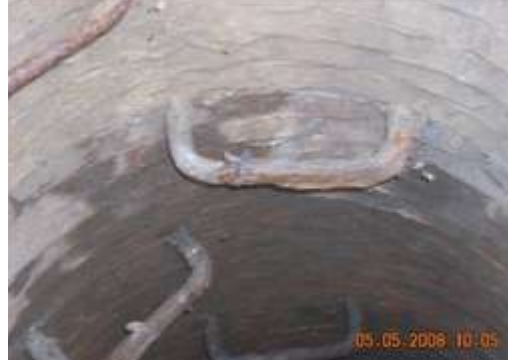
Defect 3

Infiltration: ☐ None ☒ Joint ☐ Cracks ☐ Mortar ☐ Roots ☒ Wall

infiltration @ corbel wall

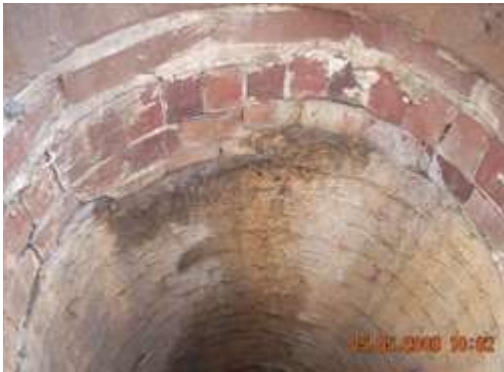
Defect 2

infiltration @ corbel/chimney joint

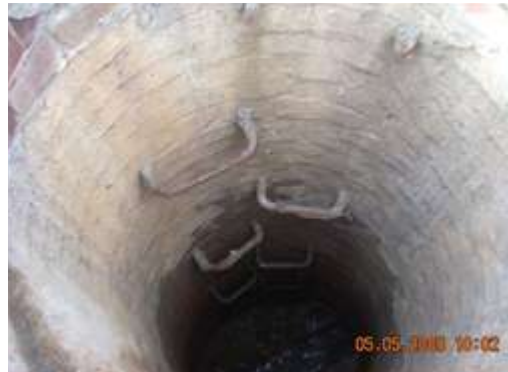
Defect 1

Steps Count: **8** Missing: **1** ☒ Corroded

corroded and missing steps

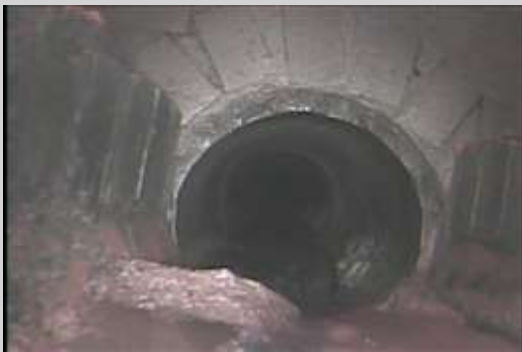
12 O'Clock Outflow

Pipe Height: **9.6** (in.) Rod and Bar (Angled)
Pipe Material: **Clay** ☐ Pipe Lined
Invert Depth: **15.10** (ft.) Flow Characteristics: **Slow**
Deposits: ☐ None ☐ Mud ☐ Sludge ☐ Debris ☒ Grease
Silt Depth: **2** (in.) Deposits Extent: **Light**
Infiltration: **None** Pipe Seal Cond: **Sound**
